建築と都市
Architecture and Urbanism
12:04

Feature:
Small and Sustainability

EM2 Architekten

Renovation 'Alter Widum'
Alto-Adige, Italy 2011

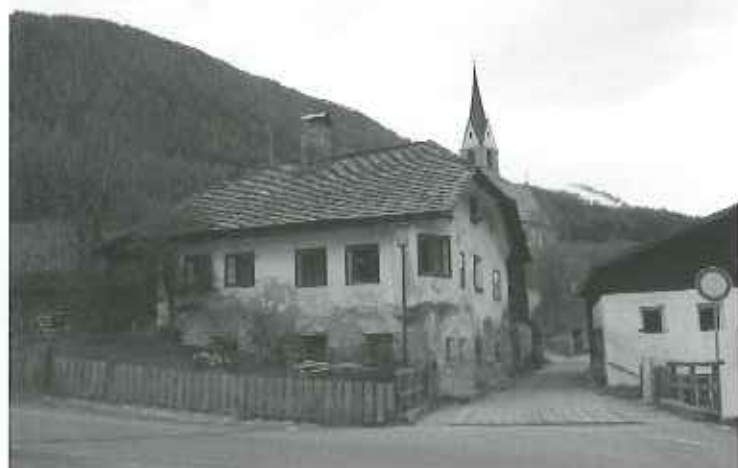
pp. 70-71: View of the roofs from the northwest. p. 72, above: View of the south facade. p. 72, below: The building before renovation in 2006. Photo courtesy of the architects. p. 73, above: Kitchen. p. 73, below: Black barrel-vaulted curing room. Opposite: Staircase. This page: Interior view of level 2. Photos on pp. 70-75 except as noted by Günther Richard Wett.

The building was in a desolate state: the shingle roof was crumbling, the wooden ceilings were rotting through, and the masonry was moist. The wood panelling and beams were decaying from dry rot, and the panelling on the ground floor was rotten up to beneath the ceiling. Cleaning needed to be done with care and sensitivity in order to preserve the character and charm of the building after the renovation.
